Slope Stability Assessment of Korre Village Landslide, SW of Shaqlawa Town, the Kurdistan Region

Varoujan K. Sissakian^{1,2}, Hassan O. Omer¹ and Zryan T. Mustafa³

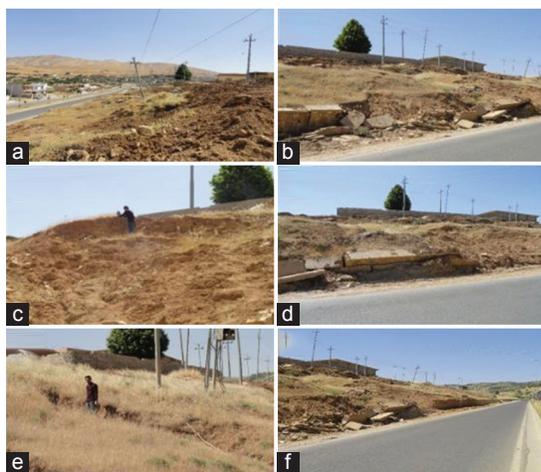
The studied area represents a road cut along the main paved road between Salahaddin and Shaqlawa towns. The length of the unstable slope is 180 m. The height difference between the road level and the highest unstable part of the slope is 30 m. The slide type is of soil sliding accompanied with a flow that had overflowed on the constructed retaining wall [Figure 4 a, b and d]. The main slid mass is in the central part of the unstable slope with a scarp of 1.5 m [Figure 4c], length of 12.40 m and slope of 12° , with many crescent-shaped cracks in the, slid mass [Figure 4f].

Figure 4. (a) Side view (looking northwards), (b) side view (looking northwards), (c) the develop scarp in the crown area, (d) the destroyed retaining wall, (e) longitudinal cracks, (f) crescent-shaped cracks developed in the slid mass

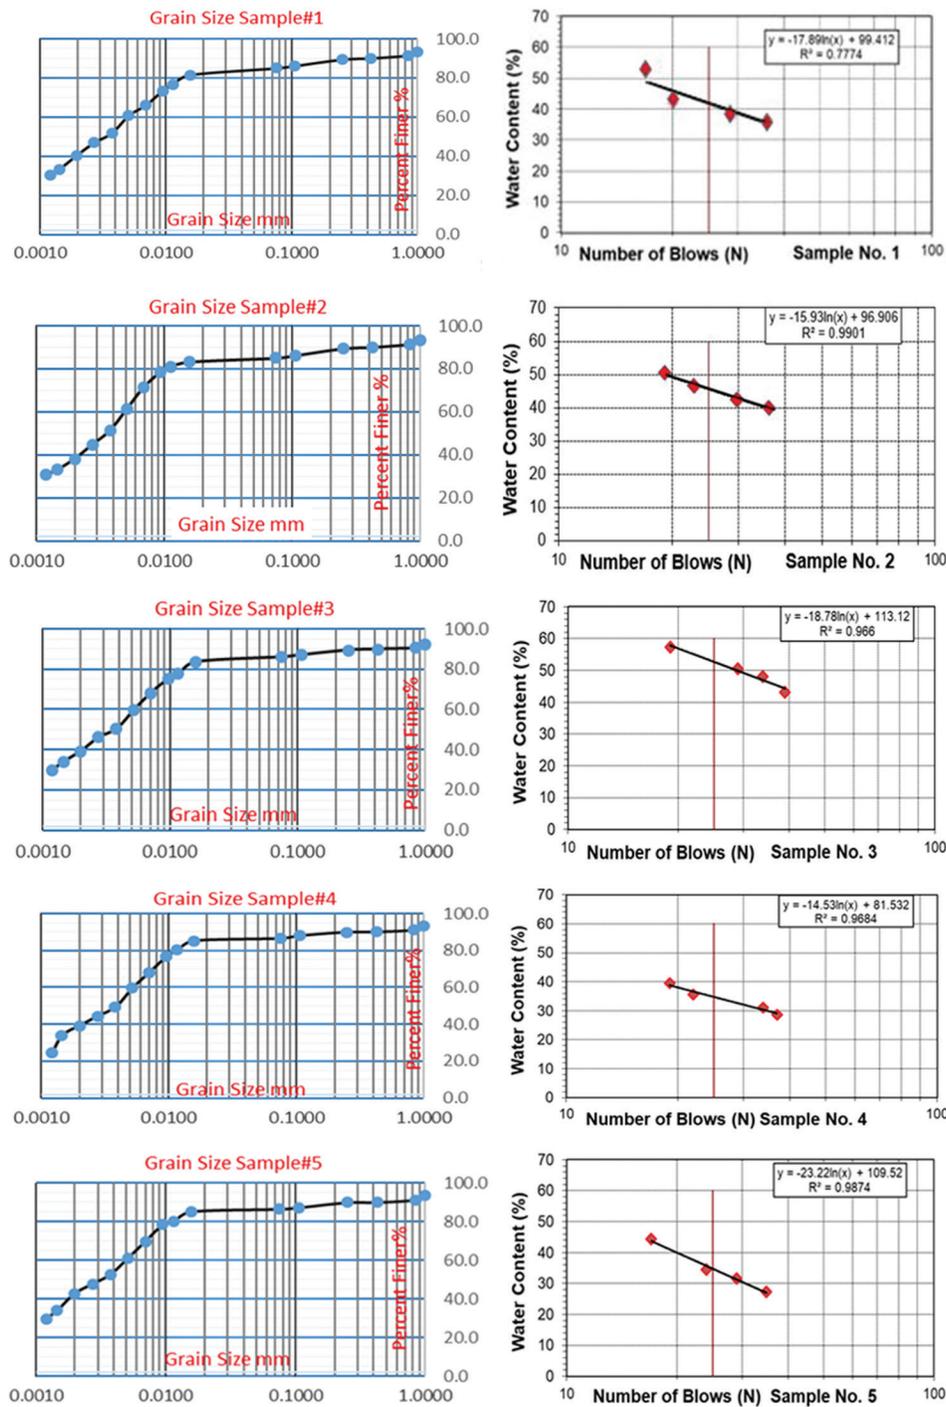
results of the tests are presented in Table 5. The cumulative curves of the grain size analyze and those of the Atterberg limits are shown in Figure 5. According to the Unified Soil Classification System (USCS), the five samples are classified as low plasticity clay “CL.” By imposing the acquired geotechnical data [Table 5 and Figure 5] on the USCS chart, we have found that the soil type in the studied area is of the CL type. It means lean clay with low plasticity index, which will not behave as plastic when loaded and unloaded again.

Figure 5. Geotechnical data of the studied samples (Left) Cumulative grain size curves and (Right) Atterberg curves

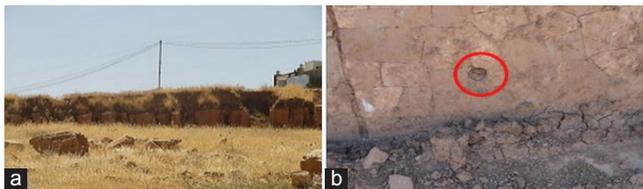
The clayey soil (lean clay) is oversaturated after heavy rain showers. The presence of limestone quarries [Figure 6a] in the upper part of the slope, facilitate the infiltration of the rainwater into the clayey soil, which is of CL type clay [Table 5] that contain 39 – 42 % clay, 40–43% silt, and 17 – 19 % sand. The Plasticity Index values range from

walls (Terzaghi, 1934; Ambrose, 1991; and FAO, 2017). The installed draining pipes in the retaining wall were not sufficient and were not designed properly; therefore, they were blocked by washed fine-grained soil [Figure 6b].

Figure 6. (a) Small rock quarry in the upper part of the failed slope, it facilitates the infiltration of the rainwater in the soil; consequently, accelerates the failure and (b) A blocked draining pipe

- a. Preventing of quarrying LB from the existing small quarries in the upper part of the slope [Figure 6a].
- b. Construction of many ditches from the uppermost part of the slope downward to the road and lining the ditches with relevant impervious material to reduce infiltration of the rainwater in the soil. The already existing vertical erosional rills [Figure 9a] can be used as draining ditches; after being lined with impervious relevant material.
- c. Construction of a relevant retaining wall, with acceptable height and width, using reinforced concrete.
- d. Providing the retaining wall with proper draining pipes to avoid oversaturation of the soil behind the wall. On the opposite side of the landslide, a proper retaining wall is constructed with the excellent draining system. The slope is higher than the failed slope, but is still stable [Figure 9b].

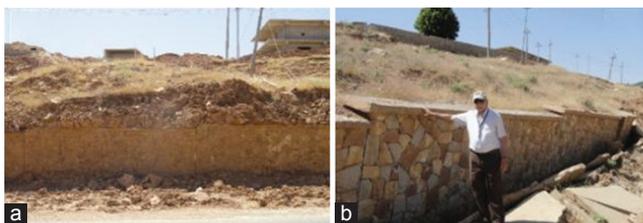
The designed retaining wall is improper; as the height, construction materials, and thickness are concerned [Figures 7a, b and 8a]. The height of the wall is $< \frac{1}{2}$ of the slope height [Figure 7b]. Therefore, the wall could not resist the pressure exerted by the sliding of the clayey soil; accordingly, it was collapsed down and damaged, and locally, overtopped [Figure 7a and 8a]. To the left side of the main slid mass [Figure 7b], the retaining wall is already pushed off; it will collapse down in the next rainy season, if not proper precautions are considered in the reconstruction of the damaged retaining wall.

Figure 7. (a) Topped soil over the retaining wall, note the poorly designed drainage system in the retaining wall, almost no draining pipes are installed and (b) Note the height of the retaining wall (About 1.65 m) and compare it with the height of the slope

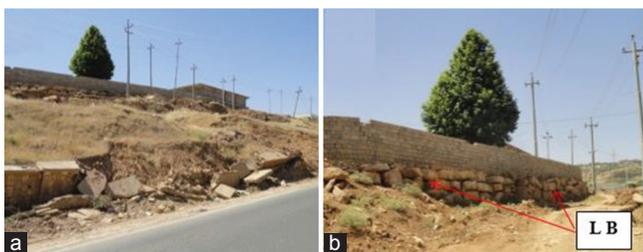
Figure 8. (a) The damaged retaining wall, note the height, thickness and used construction materials; all are improper. (b) Large limestone blocks used in the leveling of the ground below the house; consequently, causing overweight of the slope and its failure

The local people have used large limestone blocks (LB) in their houses for leveling purposes. The size of the blocks ranges between 0.25 and 0.5 m³, which means the weight of each block ranges between 0.625 and 1.25 tons per block. At least, 40 blocks are used in one single house [Figure 8b]; it means about 37 tons. The used rock blocks are within the effective zone of the slope because the slope is about 24° and the height of the retaining wall is 1.5 m [Figures 7 and 8a]; therefore, the exerted weight of the LB [Figure 8b] will be within the effective zone. Accordingly, the weight of the LB has caused overweighting of the slope, which facilitates the soil failure; such cases are well explained by Terzaghi (1943).

The used LB in the leveling of the houses [Figure 8] has increased the applied external stresses over the slope. To reduce the applied stress and increase the shear strength of soil, which will stabilize the slope, the following should be performed.

Using large LB [Figure 8b and 12 a] in the construction of houses on the slope should be prevented as well as using heavy fences and benches that will overweight the slope. Moreover, the haphazardly constructed houses and unpaved roads [Figure 12b] should also be re-planned; the unpaved roads should be paved with proper draining ditches, to prevent infiltration of the rainwater in the soil.

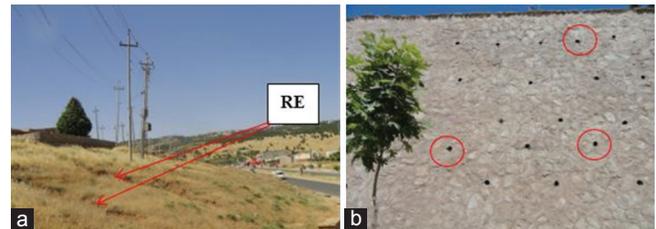
Figure 9. (a) Erosional rills along the slope, they can be lined with impervious material and used as draining ditches and (b) a retaining wall in the opposite side of the concerned landslide, note the excellent system of draining outlets (Some are encircled by red color)

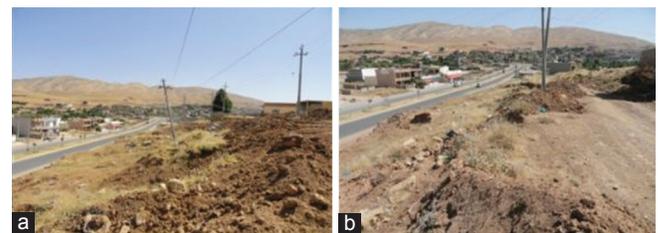
Figure 10. (a and b) The excavated materials from the toe are dumped on the already failed slope, this will increase the weight of the soil on the slope and damage the natural drainage. Accordingly, will increase the shear stress

materials from the toe area were dumped on the slope. This also has increased the weight of the slope [Figure 10] and damaged the natural drainage.

It creates a reduction in soil weight and can be accomplished by (i) removal of the soil mass at the top of the potential slide, (ii) flattening of the cut slopes above the road, and (iii) benching of cut slopes. Unfortunately, the excavated

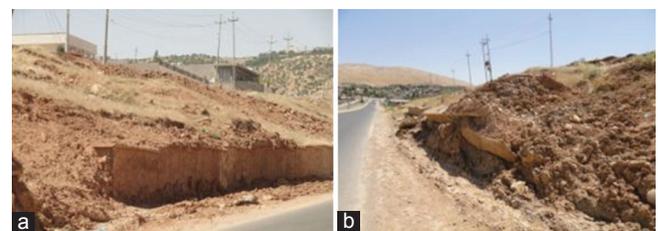
Figure 11. The toe area of the landslide is not cleaned properly. Parts of the damaged retaining wall are mixed with the slid mass, and the road's draining ditch is destroyed and dumped

This should include: (1) Excavating the toe area of the landslide [Figure 11], (2) removing and replacing failed materials with lighter and more stable materials, or re-compacted debris, and (3) excavating to unload upper portions of a mass failure, and filling to load the lower portions of a mass failure.

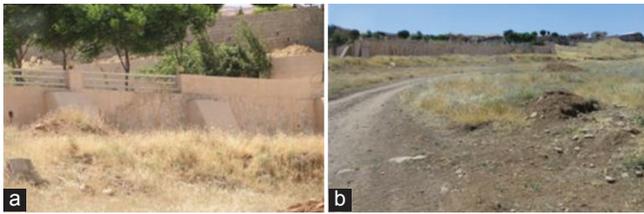
Figure 12. (a) A heavily constructed house on the slope and (b) haphazardly constructed houses and unpaved roads. This will increase the infiltration of the rainwater in the soil and will increase the failure possibility
