# The Status of Mosul Dam, NW of Iraq

Varoujan K. Sissakian<sup>1,a,\*</sup>, Nasrat Adamo<sup>2,b</sup>, Nadhir Al-Ansari<sup>3,c</sup>, Jan Laue<sup>3,d</sup>, Aayda D. Abdulahad<sup>4,e</sup>

Mosul Dam is located in the northwestern part of Iraq impounding the Tigris River; about 60 km north of Mosul city. This project is multipurpose project; to provide water for irrigation, flood control and hydropower generation. The dam is 113 m high and 3650 m long including the spillway. The dam is earth fill type with a mud core. The dam was designed to impound 11.11 km<sup>3</sup> because it is based and underlain by gypsum beds alternated with limestone and marl. Therefore, it is planned to use continuous grouting to fill the karst caverns. The used quantity exceeded 95000 tons of solid grouting materials since 1986 up to 2014. After all, is the dam safe? The details are given in the current article.

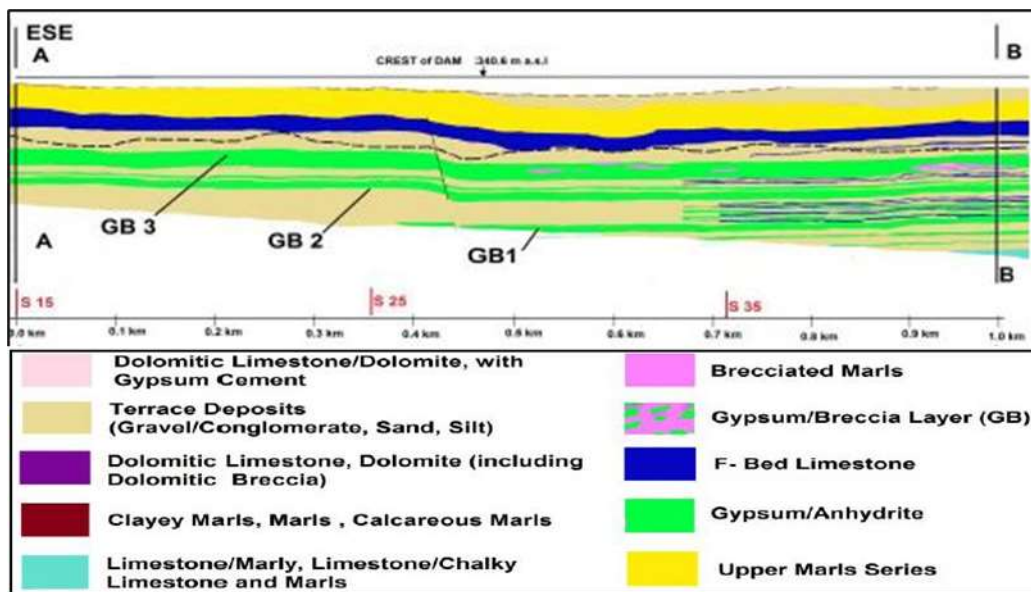
Figure 2. Cross Section on Mosul Dam Axis Showing the Cyclic Sediments of the Fatha Formation. The dashed line represents karstification level, GB = Gypsum bed (Al-Ansari *et al.*, 2015c).

Figure 2 shows the karstification line which was used to indicate the depths of the grouting boreholes, and it shows that there are many gypsum layers below the line. Those gypsum beds will dissolve, and voids and caverns will be developed, and the grouting materials will go down in the developed caverns below the karstification lines.

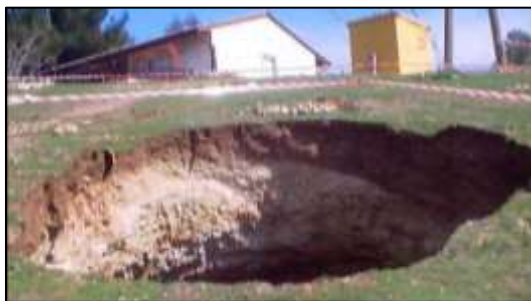
Figure 3. A Recent Developed Sinkhole (Down-Stream) After Filling of the Reservoir (Al-Ansari *et al.*, 2015b).

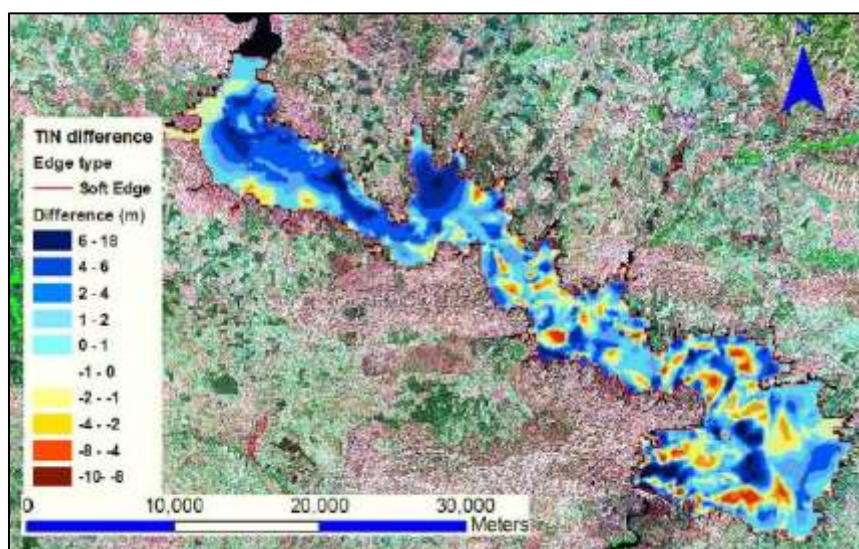
*Issa et al. (2003) conducted bathymetrical survey in the reservoir of Mosul Dam to show the changes in the reservoir bottom morphology with time (1983 – 2001) due to erosion and sedimentation processes. Accordingly, an erosion and sedimentation map was generated (Figure 4). The erosional areas with maximum depth of 9.6 m are believed to represent sinkholes and gypsum dissolved areas (Kelley et al., 2007 ; Wakeley et al., 2007). Some of these sinkholes are about 15 m in diameter and more 15 m in depth (Washington Group International, 2005).*

Figure 4. TINs for Survey 2011 and 1983 of Mosul Reservoir (Issa *et al.*, 2003).
