Performance of Unreinforced Hollow-Block Masonry Houses During 23 August 2017 Ranya Earthquake

Abstract

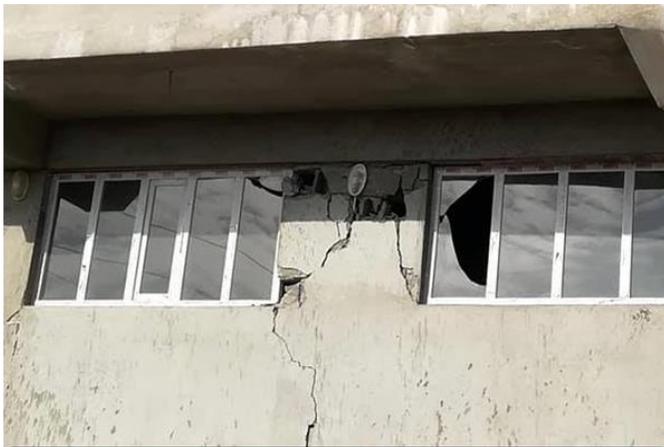
From the observations in Figure 3, it is apparent that the diagonal tension forces primarily cause these types of cracks, as shown in Figure 4, a schematic diagram showing the mechanism of cracks at corners. These cracks pass through the mortar joints or diagonally through the masonry units. They mostly begin at the corners of the windows and doors.

a. Cracking of spandrel wall between openings

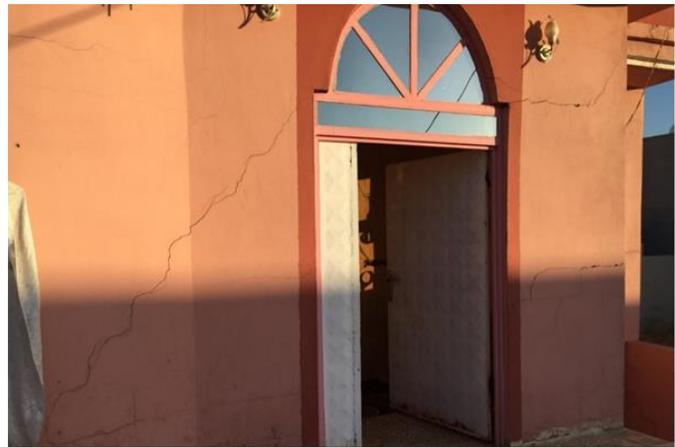
b. Cracks at the corners of openings (door)

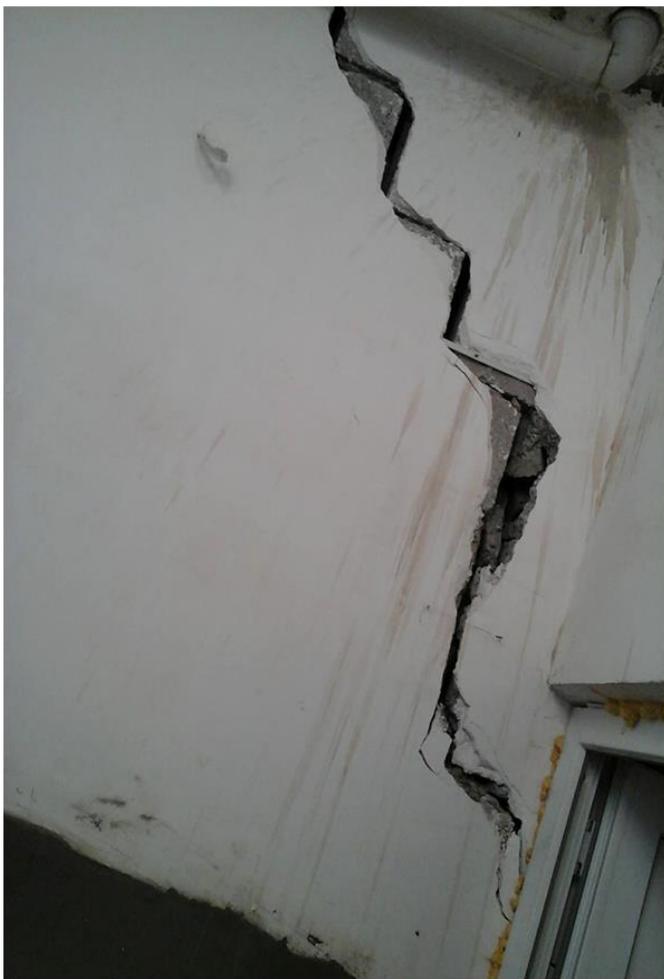
c. Diagonal stepped shear cracking

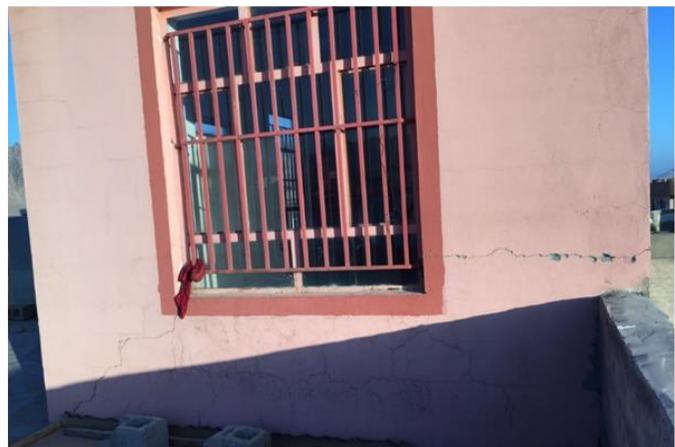
d. Cracks at the corners of openings (window)

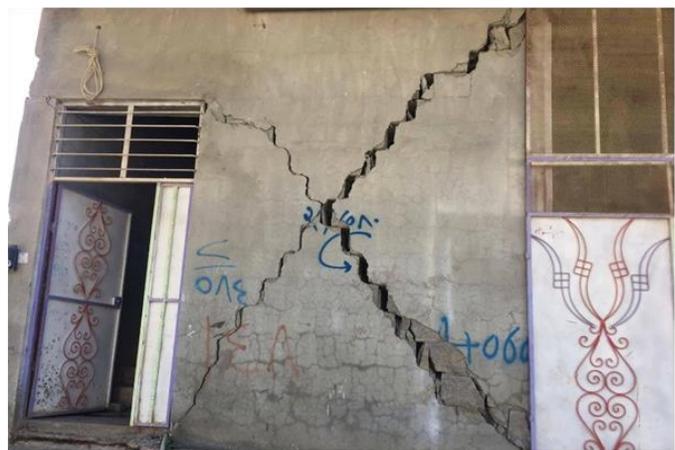
e. Double diagonal shear cracks (x shape)

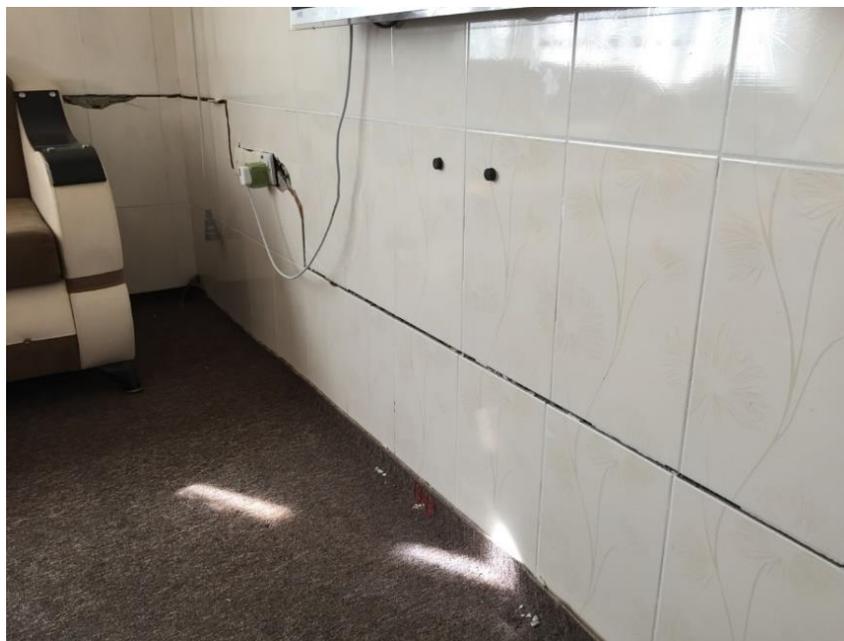
In-plane damage and cracks are produced excessively due to the intense long ground motions. This is mainly dependent on the aspect ratio of the wall, which in turn generates excessive shear forces. If this ratio is moderate, tension cracks appear on the walls diagonally (Decanini et al., 2004). During the earthquake reversal of loading, the cracks become double diagonal shear cracks that have an X shape (see Figure 3e). A study investigating the seismic risk of unreinforced masonry buildings (Erbay, 2004) reported that the cracks become stair-stepped diagonal cracks and horizontal flexural cracks in the central part of the walls (see Figure 5). These damage patterns are typical to walls that run parallel with the direction of shaking. Due to their orientation, these walls provide the lateral load resistance of the building and undergo in-plane deformation and stresses.

Figure 5. Horizontal Shear Crack at the Base of The Wall.

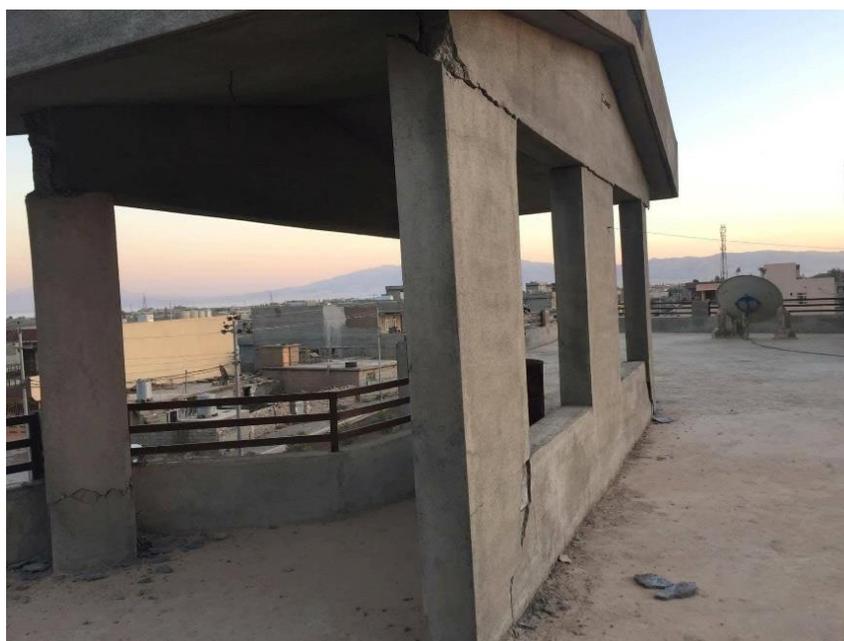
Pindoria et al. (2001) revealed that unreinforced masonry walls with small and few windows and doors experience less deterioration during earthquakes. Moreover, the earthquake resistance of the walls increases where the openings are far away from the corners. On the other hand, shear failures may occur to the walls with several numbers of openings. This concludes that the resistance of an unreinforced masonry building is considerably reliant upon the position, number and extent of the openings (see Figure 6).

Figure 6. Cracks in Load-Bearing Masonry Walls With Many Openings.

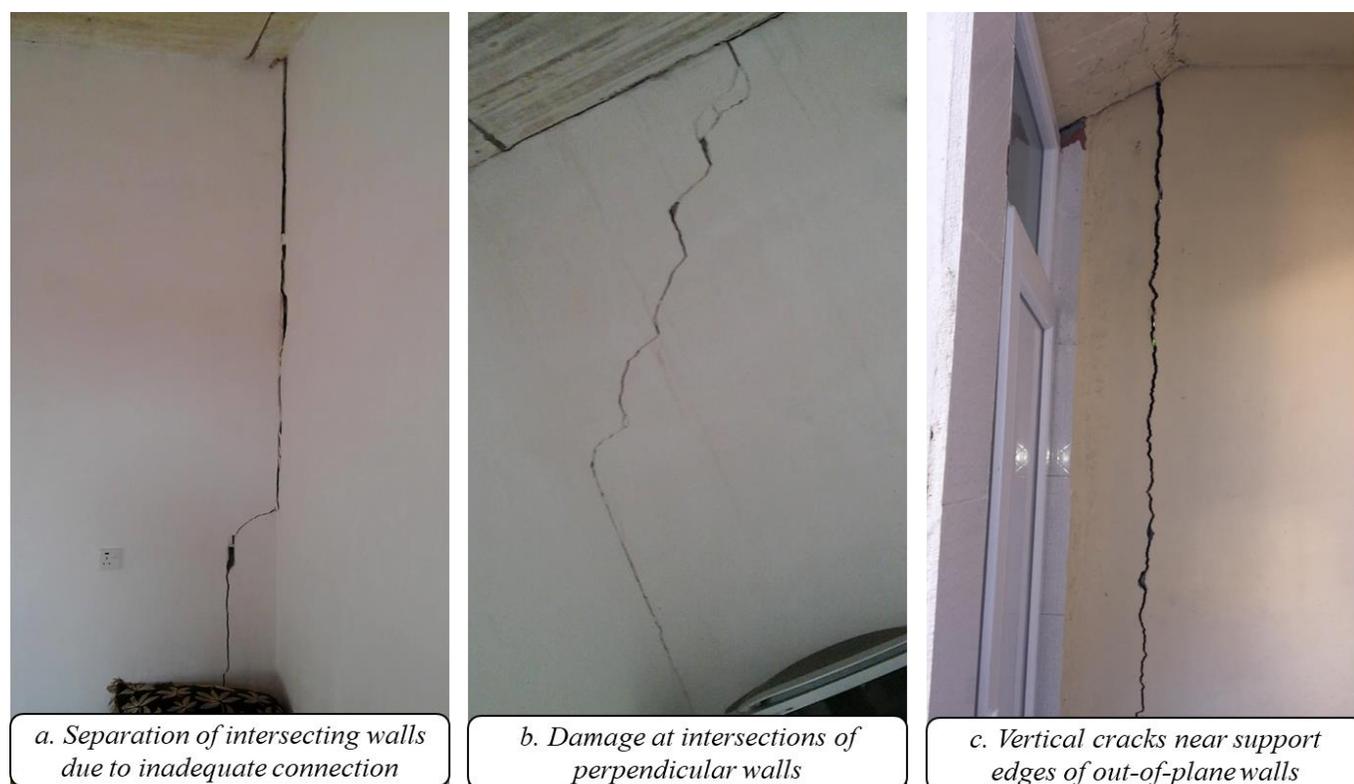
vertical tension cracks initiate at the corners, ends and center of the walls. Simultaneously, the separation of intersecting walls at the corners becomes another mode of failure due to poor connection at the wall junctions. Figure 7 shows some of the damage and out-of-plane vertical cracks that occurred to the unreinforced masonry concrete hollow block walls.

Figure 7. Corner Failure of Hollow-Block Masonry Houses.

The out-of-plane bending generated by the perpendicular inertial forces on the walls is the primary cause of higher tensile stresses at the corners and this induces vertical cracks.
