Performance of Unreinforced Hollow-Block Masonry Houses During 23 August 2017 Ranya Earthquake

Abstract

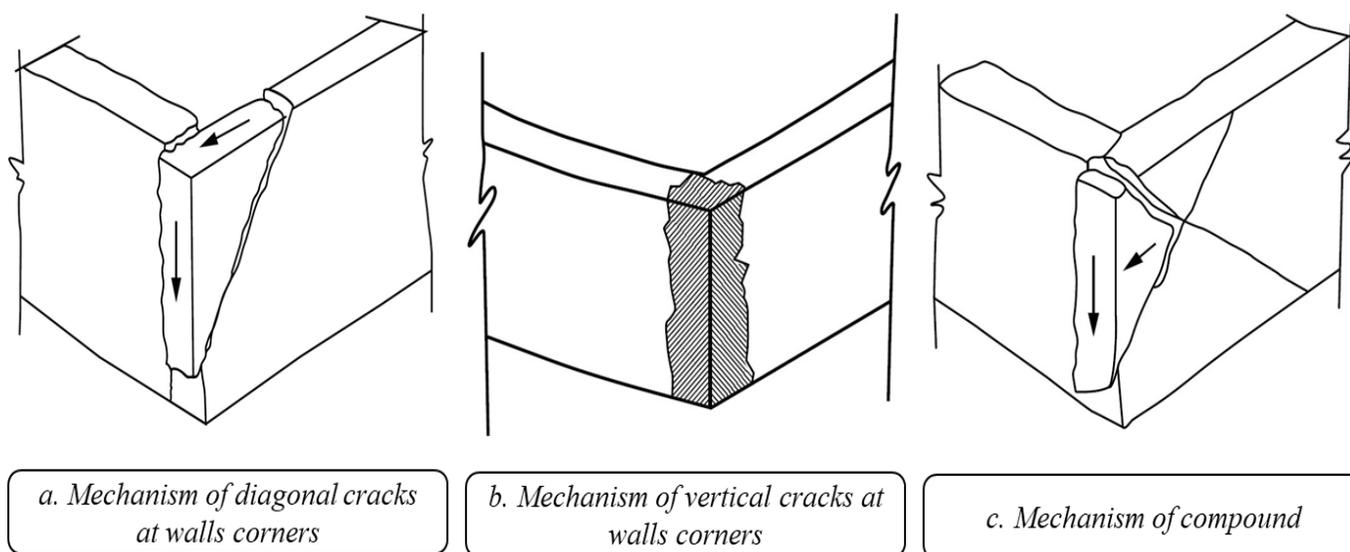
From the observations in Figure 3, it is apparent that the diagonal tension forces primarily cause these types of cracks, as shown in Figure 4, a schematic diagram showing the mechanism of cracks at corners. These cracks pass through the mortar joints or diagonally through the masonry units. They mostly begin at the corners of the windows and doors.

Figure 4. Mechanism of Cracks at Corners (Mardani et al., 2019).
