Karstification Problems in the Haditha Dam, West Iraq

Abstract

Haditha Dam is constructed on the Euphrates River in the western part of Iraq completed in 1988 and located 14 km west of Haditha town. Haditha Dam is a combined earthfill and concrete dam with a total length of 9064 m. The maximum height of the dam is 57 m from the deepest point at the river channel and dam crest level is 154.00 m (a.s.l.). The storage capacity is 6×10^9 m³ at normal operation water level of 143 m (a.s.l.). The exposed formations in the dam site and reservoir area are the Euphrates (Lower Miocene) and Fatha (Middle Miocene) formations. Both formations are well known in Iraq to be karstified at different intensities. The right bank of the Euphrates River is severely karstified with tens of sinkholes of different shapes, dimensions and activities. The presence of the karstified rocks is the main reason the dam has a very long grout curtain which extends along its entire length and includes the concrete powerhouse and spillway structure in the river channel, and the right and left bank extensions. The right bank extension of the grout curtain is exceptionally long due to the extent of the sinkhole area.

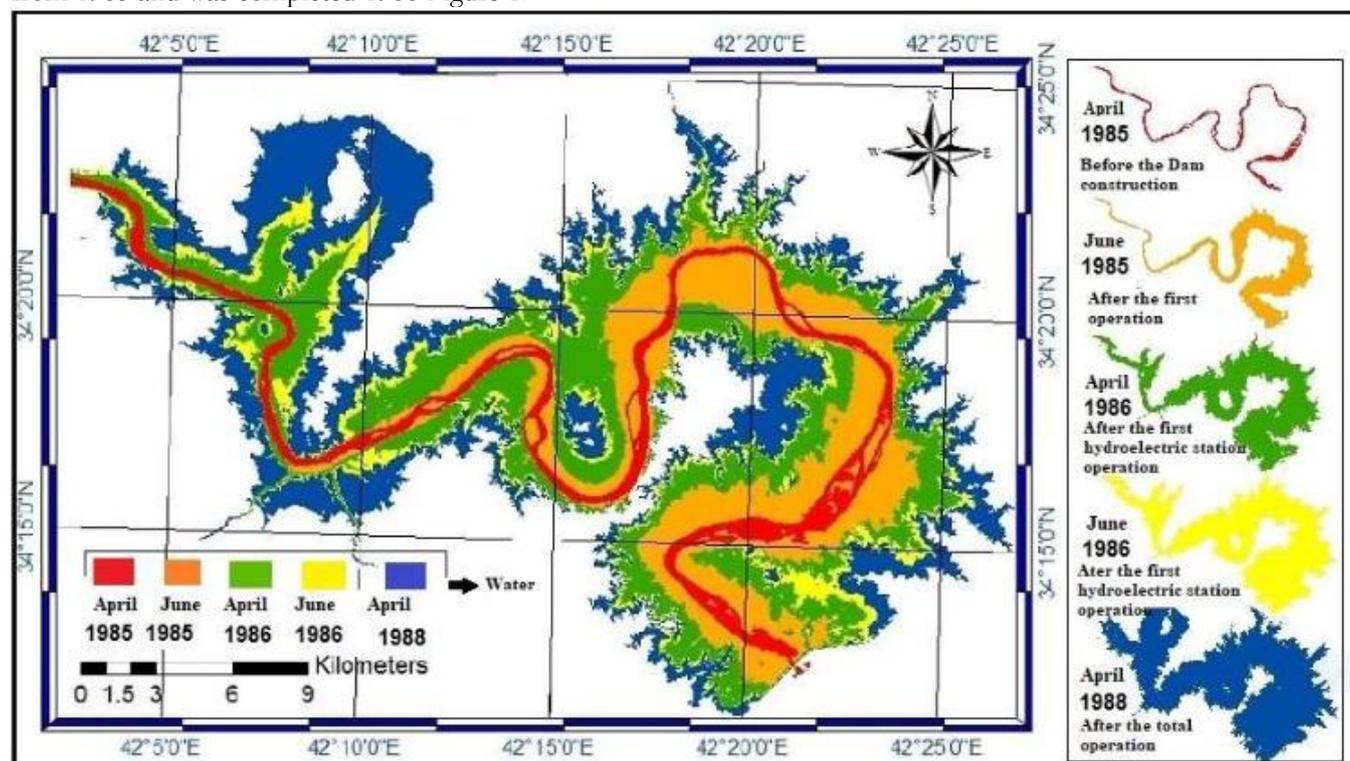
Figure 1. Variation of water surface area of Haditha Dam Lake, 1985-1988 (After Hason et al., 2020).

project that would generate hydroelectric power, regulate the flow of the Euphrates River, provide water for irrigation for the southern part of Iraq and provide security against the Euphrates River floods. The filling of the reservoir started from 1985 and was completed 1988 Figure 1.

Li et al. (2018) performed a dynamic analysis of the Haditha earthfill dam, integrated with a hydropower plant system containing six vertical Kaplan turbines. They concluded that understanding the effects of running hydropower plant turbines on the dam body is one of the major safety concerns for the earthfill dam, besides other safety concerns such as karstification. Sissakian et al. (2018) described the general geology of Haditha Dam, and Hason et al. (2020) conducted change detections study over the impounded area of Haditha Dam reservoir for many years, see Figure 1.

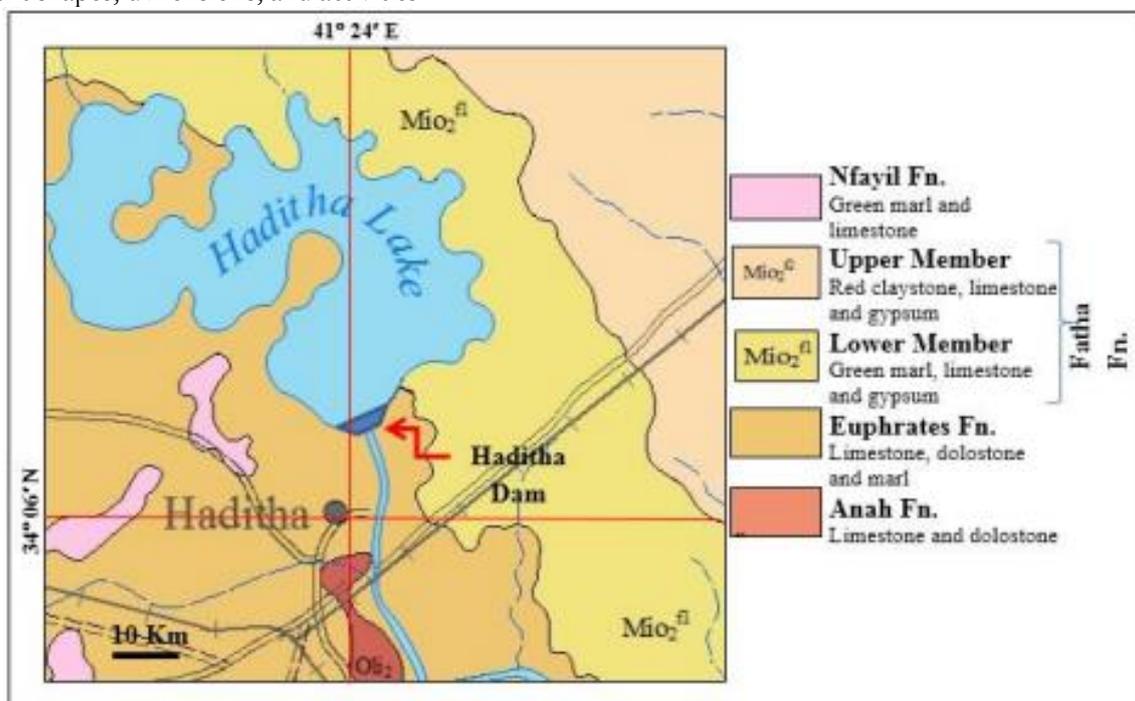
Figure 3. Geological map of Haditha Dam site and reservoir area (From Sissakian et al., 2018).

Figure 3 presents the exposed geological formations at Haditha Dam site and near surroundings as compiled by Sissakian and Qanber (1993). The following geological formations are exposed at the dam site and reservoir area:

– **Fatha Formation** (Middle Miocene): The formation is exposed only in the left bank of the reservoir area. see Figure 3. The formation is divided into two members: The Lower Member, consists of cyclic sediments, each cycle consists of green marl, limestone and gypsum. The Upper Member consists of cyclic sediments, each cycle consists of green marl, red claystone, limestone and gypsum. Locally, the uppermost cycles include fine reddish brown sandstone beds. The formation is highly karstified; exhibiting solution sinkholes.

– **Nfayil Formation** (Middle Miocene): The formation is exposed as isolated hills and/or plateaus southwest of the dam site only, see Figure 3. The formation consists of cyclic sediments; each cycle consists of green marl and limestone; maximum of three cycles were observed (Sissakian et al., 1994 and 1996).

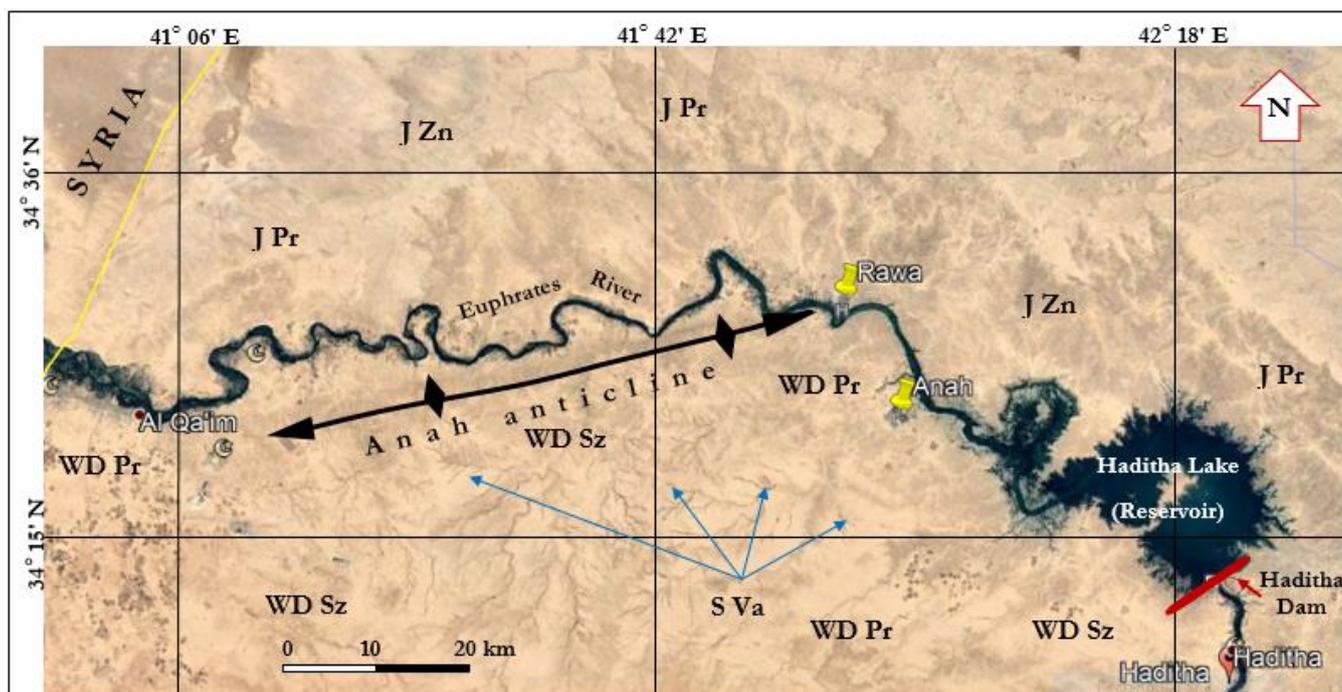
Figure 4. Satellite image showing Haditha Dam and Lake. Note that the coverage of the lake is decreased due to drought, normally it reaches to Rawa town.

Geomorphological Provinces: JPr= Jazira province, WD Pr= Western Desert Province.

The study area, including Haditha Dam and reservoir, is located in two different physiographical provinces; these are Western Desert and Al-Jazira Provinces (Sissakian and Fouad, 2012). Both provinces are characterized by flat terrain dissected by large valleys, especially the former province, see Figure 4. The main geomorphological aspects are briefed hereinafter.

The study area, of Haditha Dam site and its reservoir are located within two different tectonic zones, see Figure 4. The area north of the Euphrates River belongs to the Jazira Zone that is part of the Mesopotamia Foredeep of the Outer Platform. Whereas the area south of the Euphrates River belongs to the Western Desert Subzone of the Inner Platform. Both Outer and Inner Platforms belong to the Arabian Plate (Fouad, 2012).

Different Neotectonics evidence in different forms are present in different parts of the subzone, but all of them are not near the dam site (Sissakian and Deikran, 2009). Some fine branches of large valleys with straight trends, which are oriented in WNW – ESE trend can be seen west of the dam Figure 4; they indicate Neotectonic evidence (Sissakian, 2002). It is worth mentioning that all those structural and Neotectonic features have no significant effect on the stability of the dam. This is due to: 1) their small size, and 2) they are located far from the dam site.

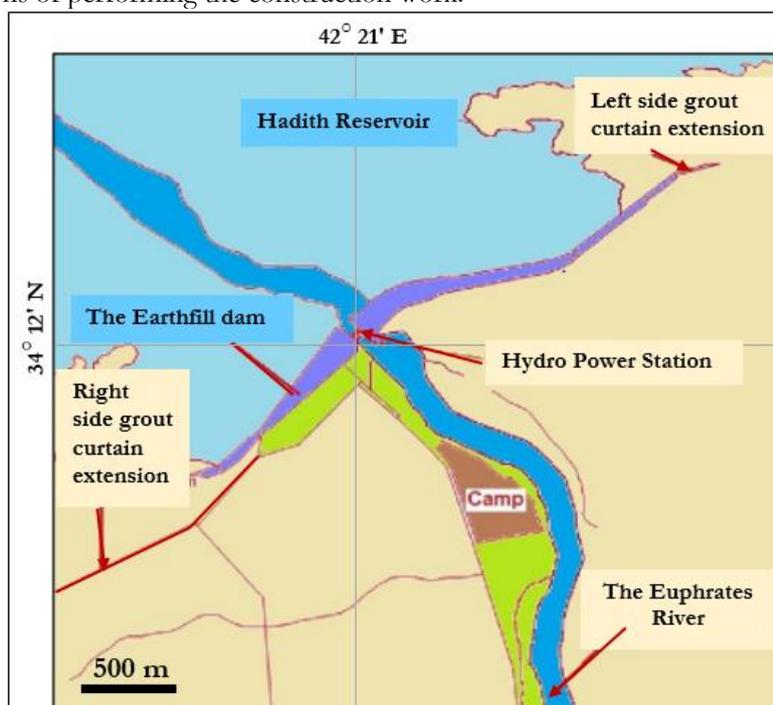
Figure 5. An illustrative map showing the length of Haditha Dam, the earthfill left and right banks, and left and right side grout curtain extensions (Adamo et al., 2018b). The authors added approximate scale and coordinates.

concrete structure, which is located at part of the river channel. The earthfill part of the dam includes 3310 m and 4985 m as the right and left abutments, respectively, and 580 m in the river channel, see Figure 5 (Adamo et al., 2018 b).

The total length of the dam is 9064 m which includes 189 m for the concrete structure in the central part. The earthfill parts of the dam are: 3310 m on the right abutment, 4985 m on the left abutment and 580 m in the river channel. Karst prevails in the foundation of the whole length of the dam and for long distances on its both sides. This is attributed to: 1) Exposures of the Euphrates Formation on the right side of the river, 2) The rocks of the Euphrates Formation (Limestone and dolostone) are highly karstified, and 3) Presence of long and deep wadis near the dam site which can work as discharging zone from the reservoir to the downstream. Whereas, on the left side, it is attributed to: 1) Exposures of the Fatha Formation on this side of the river, 2) The rocks of the Fatha Formation (Gypsum and limestone) are highly karstified, and 3) Presence of long and deep wadis near the dam site which can work as discharging zone from the reservoir to the downstream and to the Tharthar reservoir. The presence of this extensive karstification added to the dam works the necessity of extending the grout curtain under the dam for additional 10260 meter, and 635 m extensions on the right and left sides of the dam respectively.
